# COMMERCIAL PROPERTY AERIAL CONDITION SCREENING REPORT

Drone-Assisted Property Intelligence | SION Assessment Framework™ v1.0

Memphis-Area Commercial Property | July 2026 | ~4.2 Acres

**DEMONSTRATION REPORT — REAL AERIAL DATA**

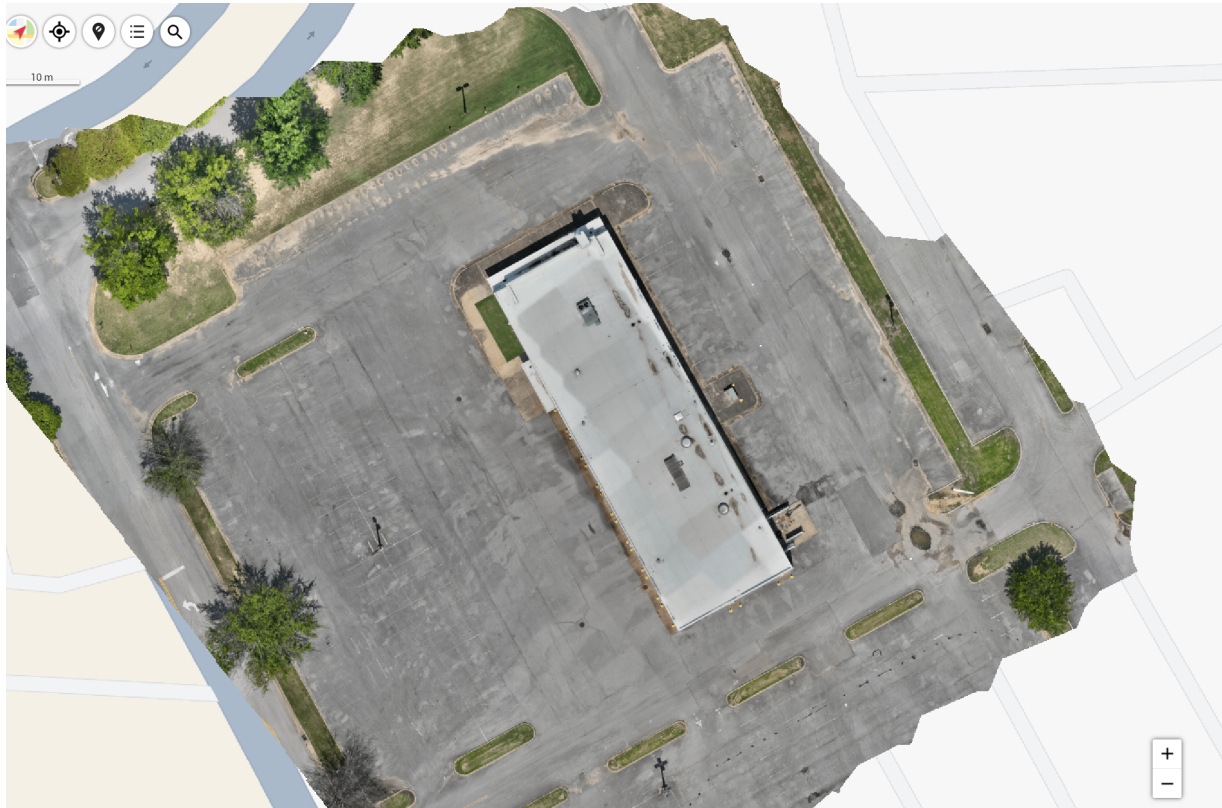
FIGURE 1: Full-site orthomosaic overview — Memphis-Area Commercial Property | July 2026

Figure 1: Full-site aerial orthomosaic showing complete site extent, parking field condition, and building context. Widespread pavement surface weathering and irregular surface patterning visible from altitude across the parking field.

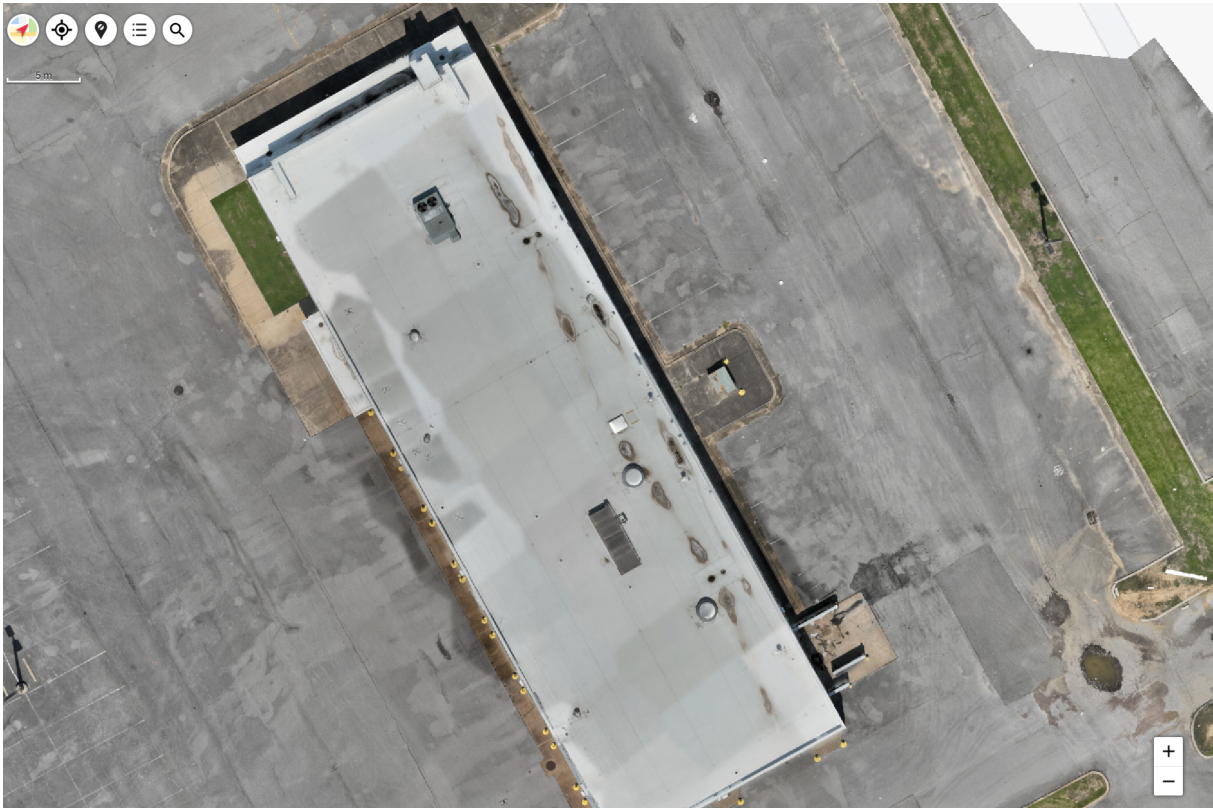
FIGURE 2: Close-range roof orthomosaic — Memphis-Area Commercial Property | July 2026

Figure 2: Close-range aerial orthomosaic of building roof. Roof membrane, HVAC units, penetrations, and drainage features visible. Roof membrane appears generally intact. Staining, discoloration, and penetration areas flagged for qualified follow-up inspection.

| MEMBRANE RATING | HVAC UNITS | PENETRATIONS | DRAINAGE |
|---|---|---|---|
| GOOD — 82/100 | Visible — Verify Curbs | Multiple — Verify Seals | Needs Verification |

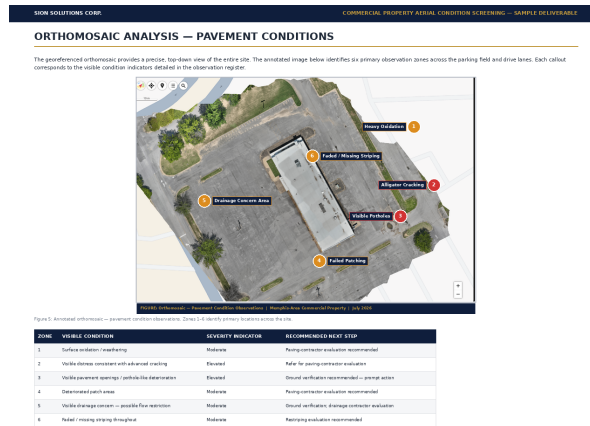
FIGURE 5: Annotated orthomosaic — Pavement Condition Observations | Memphis-Area Commercial Property | July 2026

Figure 5: Annotated orthomosaic — pavement condition observations. Zones 1-6 identify primary locations across the site.

| ZONE | VISIBLE CONDITION | SEVERITY INDICATOR | RECOMMENDED NEXT STEP |
|---|---|---|---|
| 1 | Surface oxidation / weathering | Moderate | Paving-contractor evaluation recommended |
| 2 | Visible distress consistent with advanced cracking | Elevated | Refer for paving-contractor evaluation |
| 3 | Visible pavement openings / pothole-like deterioration | Elevated | Ground verification recommended — prompt action |
| 4 | Deteriorated patch areas | Moderate | Paving-contractor evaluation recommended |
| 5 | Visible drainage concern — possible flow restriction | Moderate | Ground verification; drainage contractor evaluation |
| 6 | Faded / missing striping throughout | Moderate | Restriping evaluation recommended |

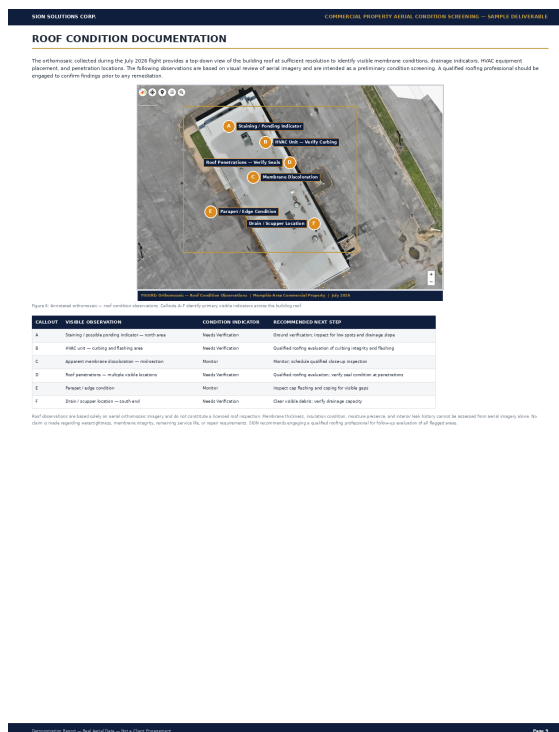
FIGURE 6: Annotated orthomosaic — Roof Condition Observations | Memphis-Area Commercial Property | July 2026

Figure 6: Annotated orthomosaic — roof condition observations. Callouts A-F identify primary visible indicators across the building roof.

| CALL OUT | VISIBLE OBSERVATION | CONDITION INDICATOR | RECOMMENDED NEXT STEP |
|---|---|---|---|
| A | Staining / possible ponding indicator — north area | Needs Verification | Ground verification; inspect for low spots and drainage slope |
| B | HVAC unit — curbing and flashing area | Needs Verification | Qualified roofing evaluation of curbing integrity and flashing |
| C | Apparent membrane discoloration — mid-section | Monitor | Monitor; schedule qualified close-up inspection |
| D | Roof penetrations — multiple visible locations | Needs Verification | Qualified roofing evaluation; verify seal condition at penetrations |
| E | Parapet / edge condition | Monitor | Inspect cap flashing and coping for visible gaps |
| F | Drain / scupper location — south end | Needs Verification | Clear visible debris; verify drainage capacity |
